# CASE STUDY

## BRIDGE FOUNDATIONS

### TOOMBUL RAIL BRIDGE REPAIR

<b>PROJECT TYPE:</b>	<b>MICROPILE FOUNDATION REPLACEMENT</b>
<b>CLIENT:</b>	<b>QUEENSLAND RAIL</b>
<b>MAIN CONTRACTORS:</b>	<b>ARK CONSTRUCTION GROUP</b>
<b>PROJECT ENGINEERS:</b>	<b>ARUP</b>

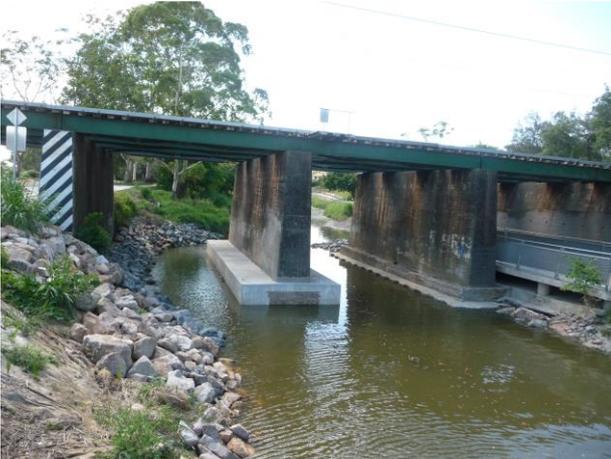
Completed foundation repair

Grout injected hollow bar micropiles were designed and installed by PCA and connected via concrete beams that were dowelled into either side of the caisson. The micropiles were drilled through the upper 10m of marine clays and gravels using a high-pressure grouting technique to provide an effective pile diameter of 300mm. Once through the upper soft soil layers, the micropiles piles were drilled 10m into the underlying coal shale to develop the design loads through skin friction. The micropiles were statically load tested in both tension and compression to verify the design assumptions in accordance with AS2159 – 2009 Pile Design and Construction.

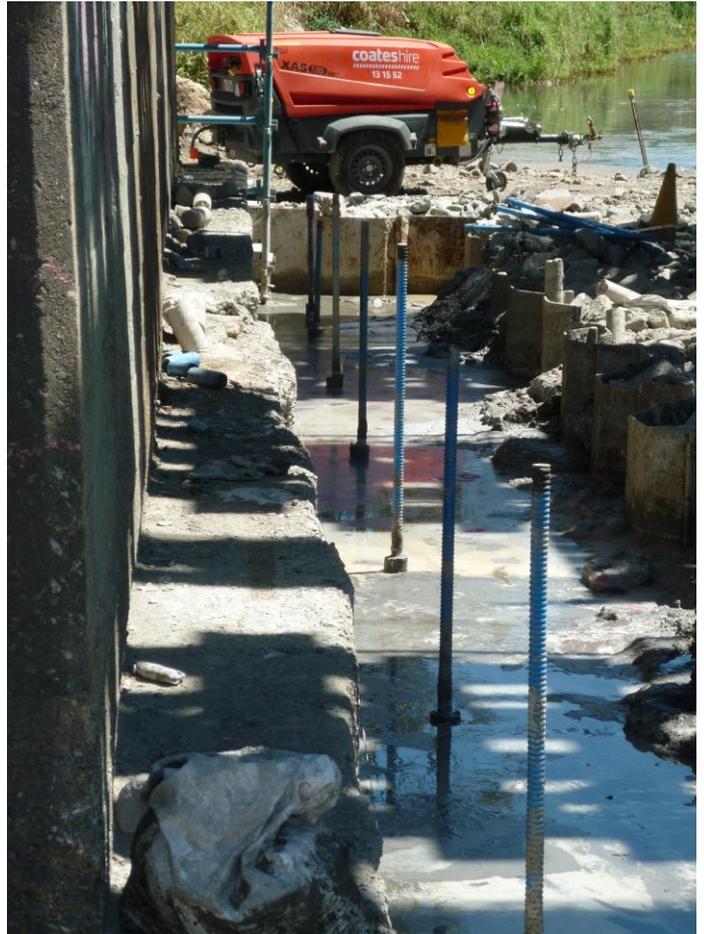
Micropile reinforcement elements installed prior to construction of edge beams.

Due to the marine conditions, a double corrosion protection hollow bar was selected which is specially manufactured to include both a hot dip galvanised layer coated with a durable outer layer of epoxy to provide the required 100 year design life.

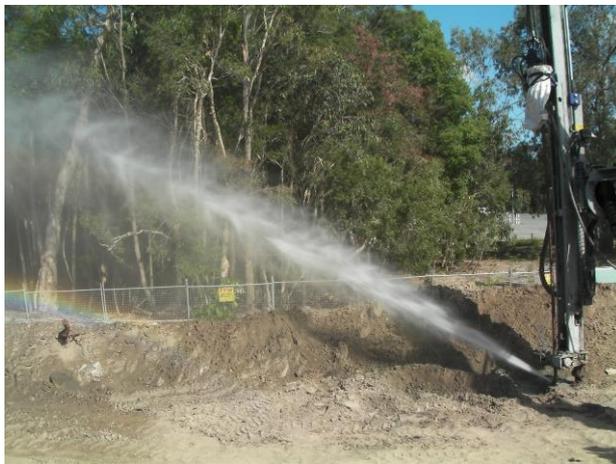
High pressure grouting was used to increase micropile diameters in upper soil layers
